# TELEVISION

SERVICING-VIDEO-CONSTRUCTION-DEVELOPMENTS

March  
1982

Vol. 32, No. 5  
Issue 377

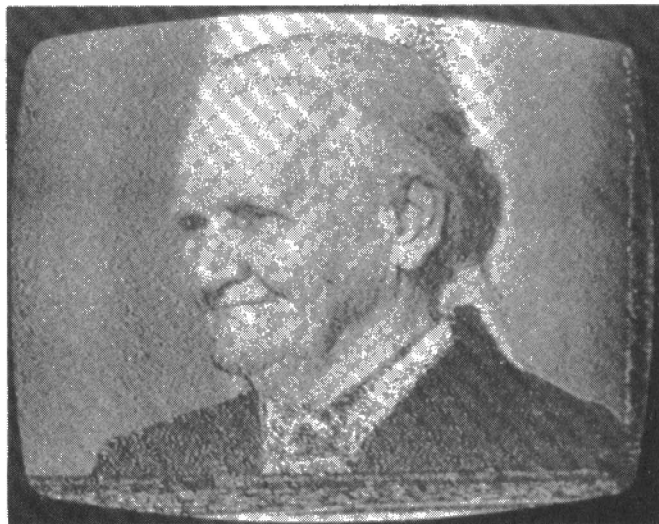
*Reception from the Russian Stat-T satellite, at 714MHz, by Ian Roberts in South Africa – showing typical picture quality.*
